# TECHNICAL NOTE

HDPE Pipe Repair Options

TN 5.03  
January 2010

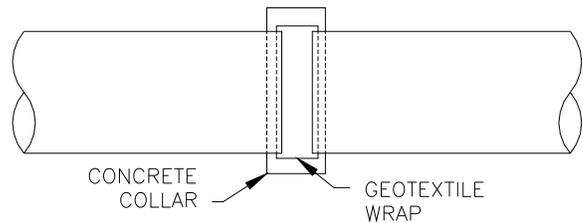
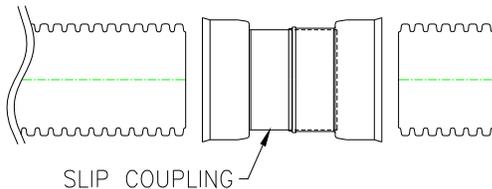
*Concrete collars* also provide a soil-tight repair, dependent on the integrity of the installation. Installing a concrete collar involves building a form around the area to be repaired and encasing it in concrete. A geotextile is usually wrapped around the repair area prior to pouring the collar to keep the concrete from seeping into the pipe. Typically, approximately 6" (0.15m) is excavated beneath the pipe to allow for proper application of the geotextile and concrete encasement. If the pipe itself is damaged, the damaged area shall be removed and a replacement pipe section spliced in prior to pouring the collar. In order to provide a greater level of joint performance, a gasket can be installed on the pipe in the concrete encasement. Concrete collars are typically more costly and time consuming than snap couplers or split band couplers but are reasonable repair options for soil-tight smooth interior corrugated HDPE pipe products.
