Land and Water

Storm Water Culvert Repair Stands Up To Weight Of Railroad Trains And Contaminated Soil

The town of Durham, New Hampshire found that sliplining with 5-foot diameter polypropylene pipe was the solution to a three-pronged problem be-

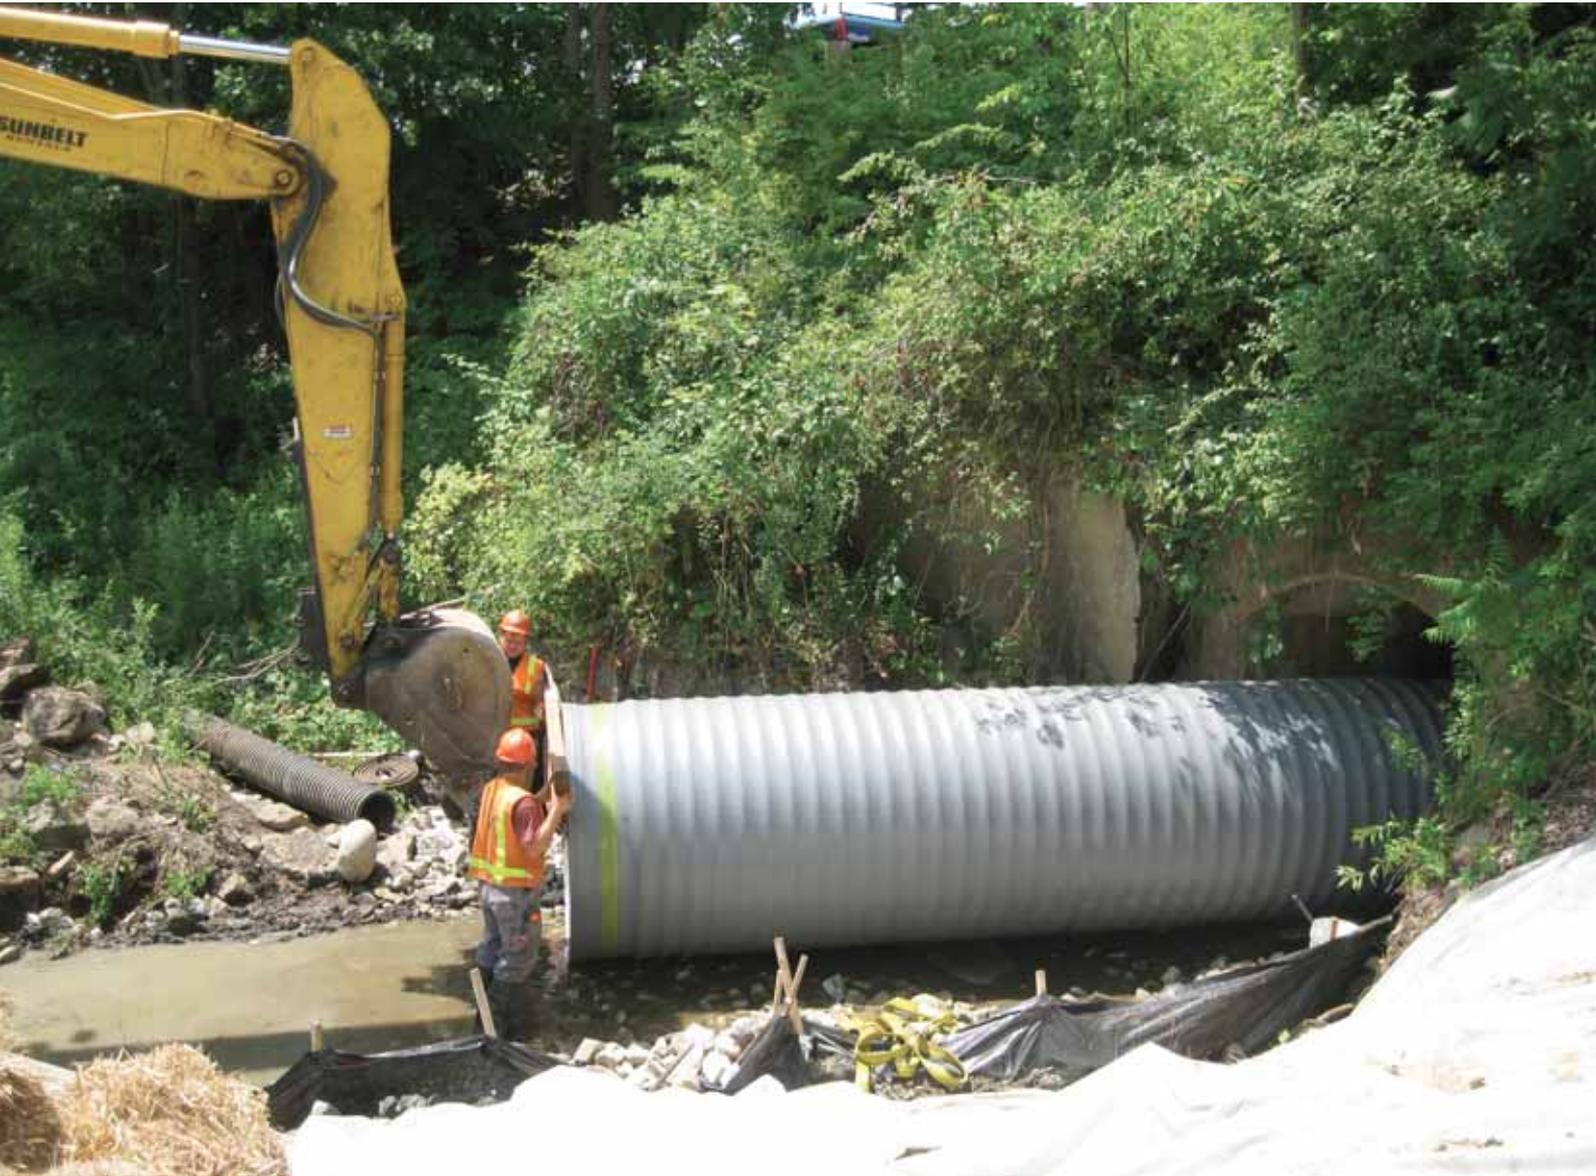
A 20-foot section of SaniTite® HP pipe being nudged into the culvert. It took the crew just hours to slipline the entire 200 feet of the culvert.

end by 8-10 inches. We shot the invert, slipped in the new pipe and had it perfect. The entire pipe system with just a little less than 200 feet of pipe was put together by a crew of four guys in a couple of hours.”

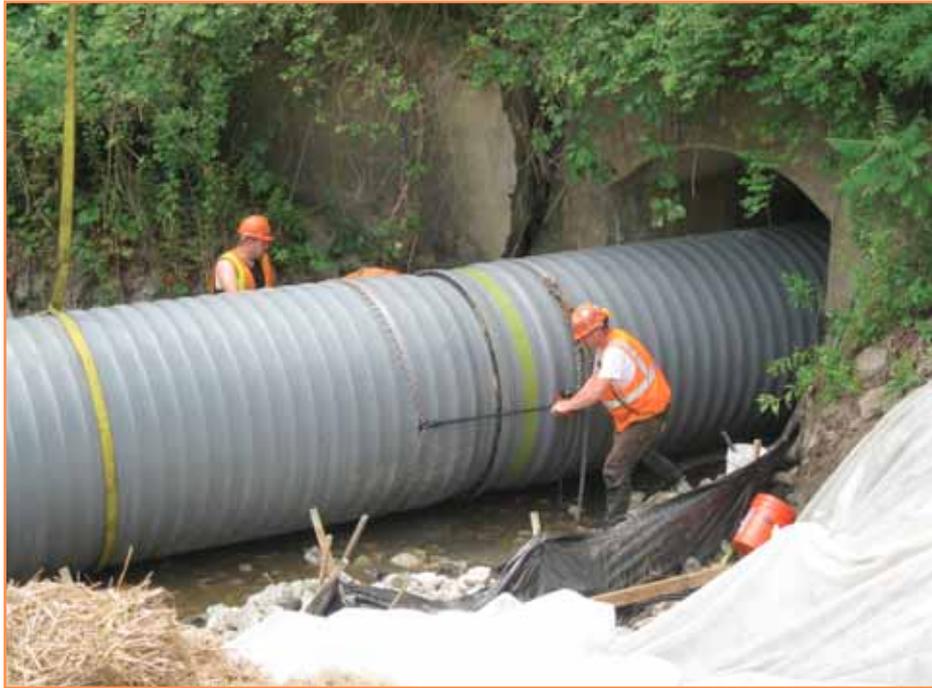
Contractor easily assembles the field joint together with ratchet straps.

they did not leak, no sign of leakage whatsoever. To say the least, we were very satisfied with the joint style, how they physically went together in the field, how easy they were for the crew to deal with and the fact that it was a tight joint. Contractors like to see it work before we really believe it. We’ve used corrugated HDPE pipe before but it’s the first time we used SaniTite HP pipe and we saw it work. My field guys are believers. And if they are, I am.”

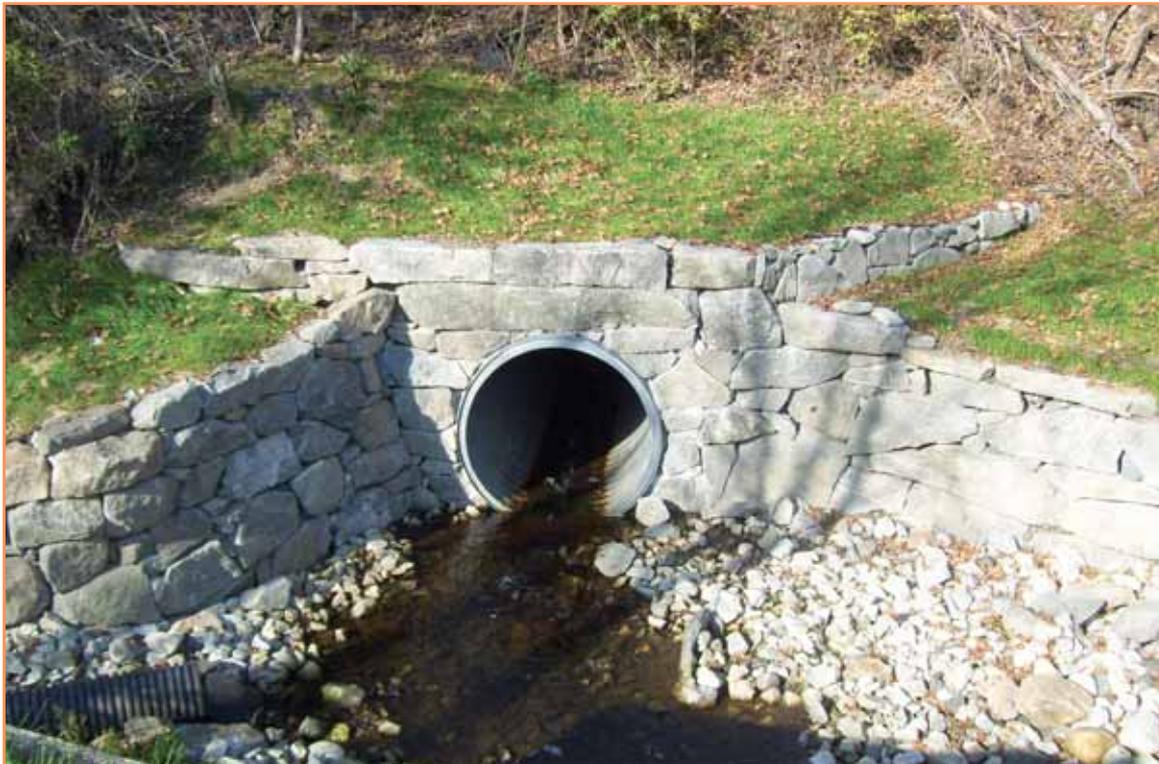
The final headwall and the 60-inch diameter pipe blends in with the surrounding area.

end where we had the masonry headwall built. So they wanted something that looked pretty nice, not just a slab of concrete. We had a standard DOT detail for the shape of the headwall, but we hired a local stonemason Rob Burnham of Millstone Stone Masonry who took that to another level and really made it fit into the topography.

“The old concrete headwall also had some real structural issues. It had a very large crack and a large portion was tipping forward. In addition, the slope above the headwall was steeper than 1:1. So the pipe actually stuck out beyond the old pipe by about 10 feet which allowed us to build the new headwall in front of the old one,” he said. “There’s compacted fill between the two that now supports the old failing headwall. We didn’t disturb any of the area above the old headwall and that was a key to the project because the soils are potentially contaminated and the vegetation is currently stable so we didn’t want to destabilize that slope. Now the new headwall supports both the slope and that old headwall. And I just love the way it came out. It has a nice clean cut face on it and

the end of the pipe blends in real nice with the stonework.”
