# Storm Water Culvert Repair Stands Up To Weight Of Railroad Trains And Contaminated Soil

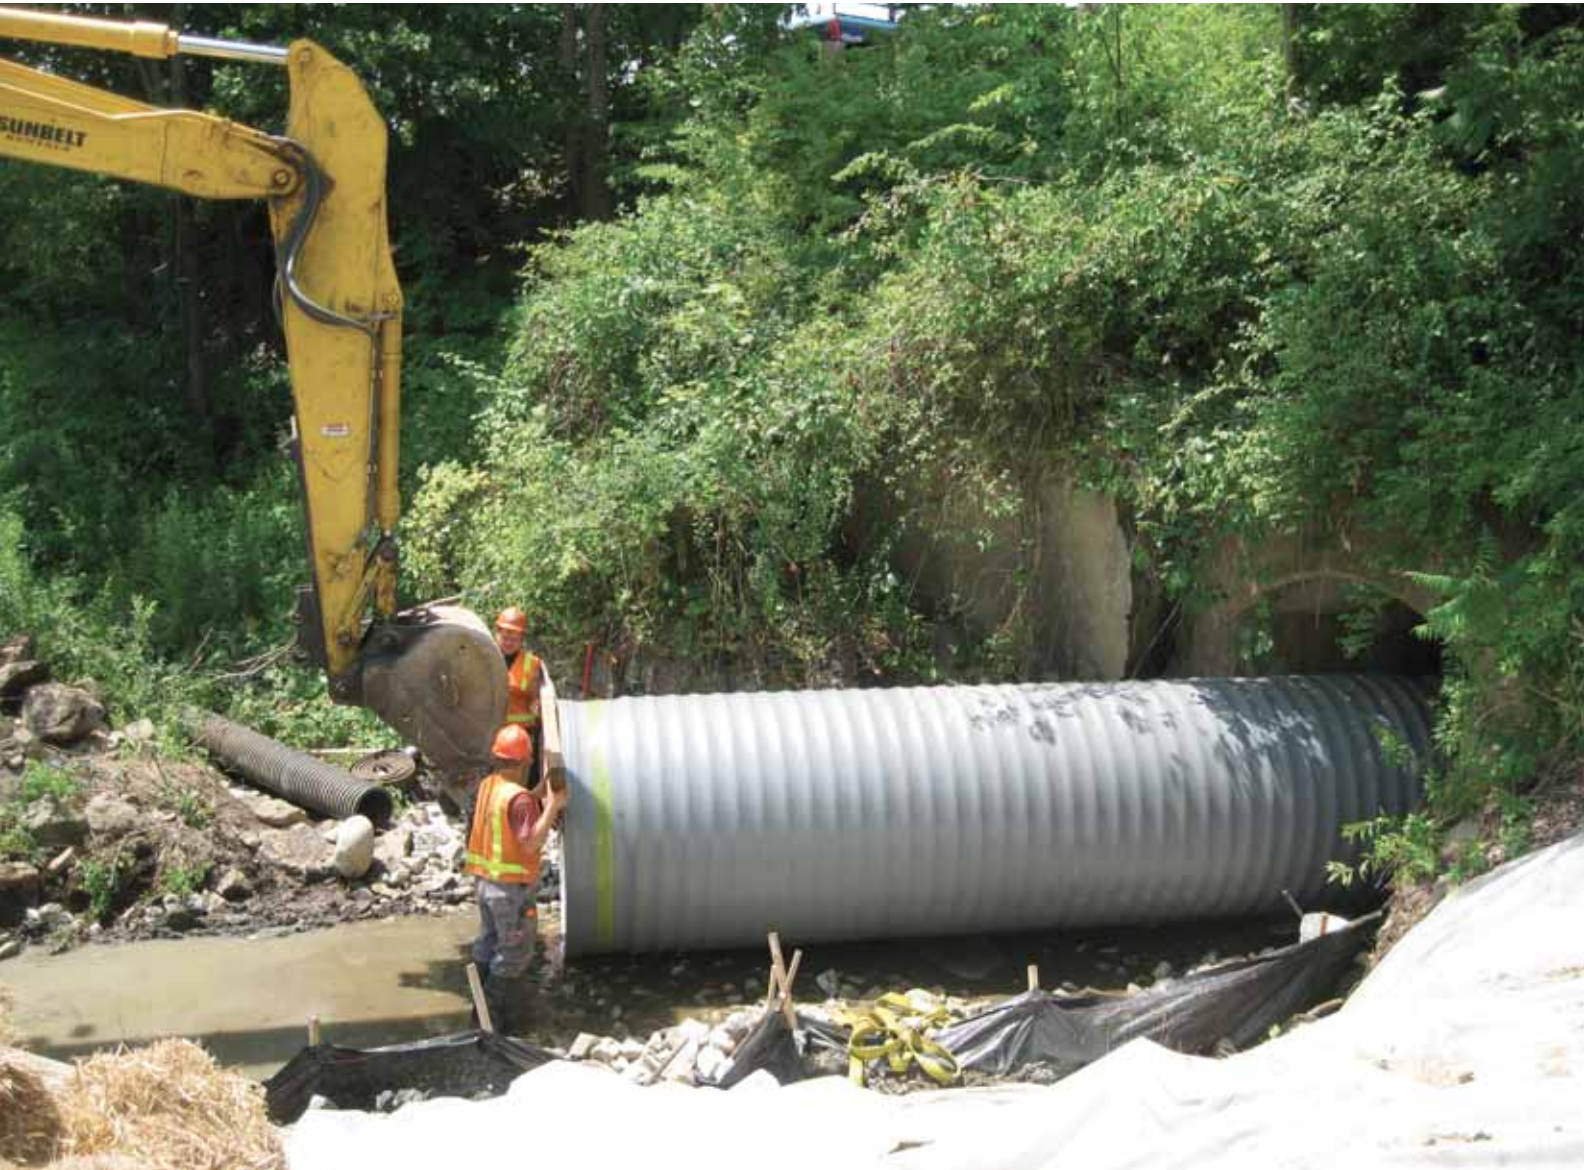
**A 20-foot section of SaniTite® HP pipe being nudged into the culvert. It took the crew just hours to slipline the entire 200 feet of the culvert.**

“Our plan called for putting in 2 x 4 rails on the base of the culvert that we could use to slide the pipe in and would allow water to flow underneath the pipe as we were building our bulkhead,” Timberlake continued.

“On the first day in the field, we set up a simple level and transit and we found that the upstream end was lower than expected. So, we had to make some adjustments to slope of the pipe to create a more consistent flow line. With the rail system, we were able to correct the pitch by raising the inlet

end by 8-10 inches. We shot the invert, slipped in the new pipe and had it perfect. The entire pipe system with just a little less than 200 feet of pipe was put together by a crew of four guys in a couple of hours.”

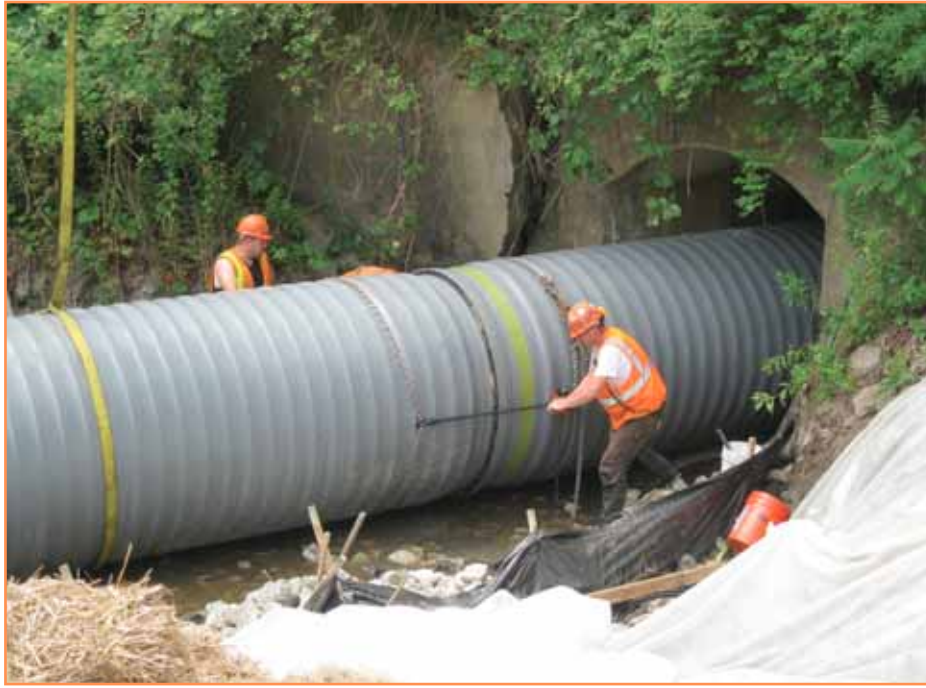
**Contractor easily assembles the field joint together with ratchet straps.**

they did not leak, no sign of leakage whatsoever. To say the least, we were very satisfied with the joint style, how they physically went together in the field, how easy they were for the crew to deal with and the fact that it was a tight joint. Contractors like to see it work before we really believe it. We’ve used corrugated HDPE pipe before but it’s the first time we used SaniTite HP pipe and we saw it work. My field guys are believers. And if they are, I am.”

could have posed a real problem if the pipe did not perform as required. “One of the concerns about any segmental pipe is the pipe joint, especially when you’re doing grouting. One of the hesitations with grouting is always if the joints leak you’ll have grout inside of your new pipe. And if that happens from a contractor’s end, that’s the most risk I have in the entire project. If I grout and the joints leak, either I ruin the new pipe or have to go in and clean concrete out of the new pipe and that’s all bad. We grouted and all the joints were tight...

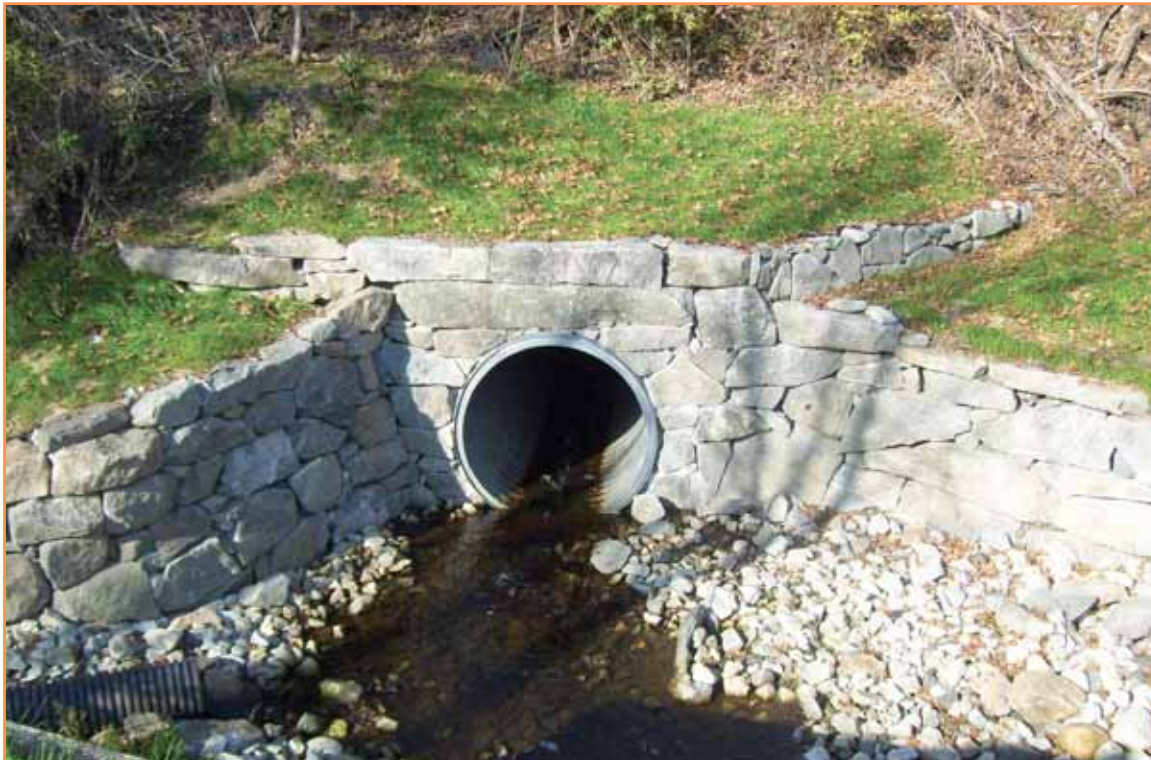
**The final headwall and the 60-inch diameter pipe blends in with the surrounding area.**

The final touch was the repair of the existing headwall. “It’s fantastic,” said Cedarholm, “with the stone work. The University’s Whittenmore Center faces that outlet

end where we had the masonry headwall built. So they wanted something that looked pretty nice, not just a slab of concrete. We had a standard DOT detail for the shape of the headwall, but we hired a local stonemason Rob Burnham of Millstone Stone Masonry who took that to another level and really made it fit into the topography.

“The old concrete headwall also had some real structural issues. It had a very large crack and a large portion was tipping forward. In addition, the slope above the headwall was steeper than 1:1. So the pipe actually stuck out beyond the old pipe by

about 10 feet which allowed us to build the new headwall in front of the old one,” he said. “There’s compacted fill between the two that now supports the old failing headwall. We didn’t disturb any of the area above the old headwall and that was a key to the project because the soils are potentially contaminated and the vegetation is currently stable so we didn’t want to destabilize that slope. Now the new headwall supports both the slope and that old headwall. And I just love the way it came out. It has a nice clean cut face on it and

the end of the pipe blends in real nice with the stonework.”
