Safety First

Michigan airport rehabilitates drainage pipe with little impact on flight operations

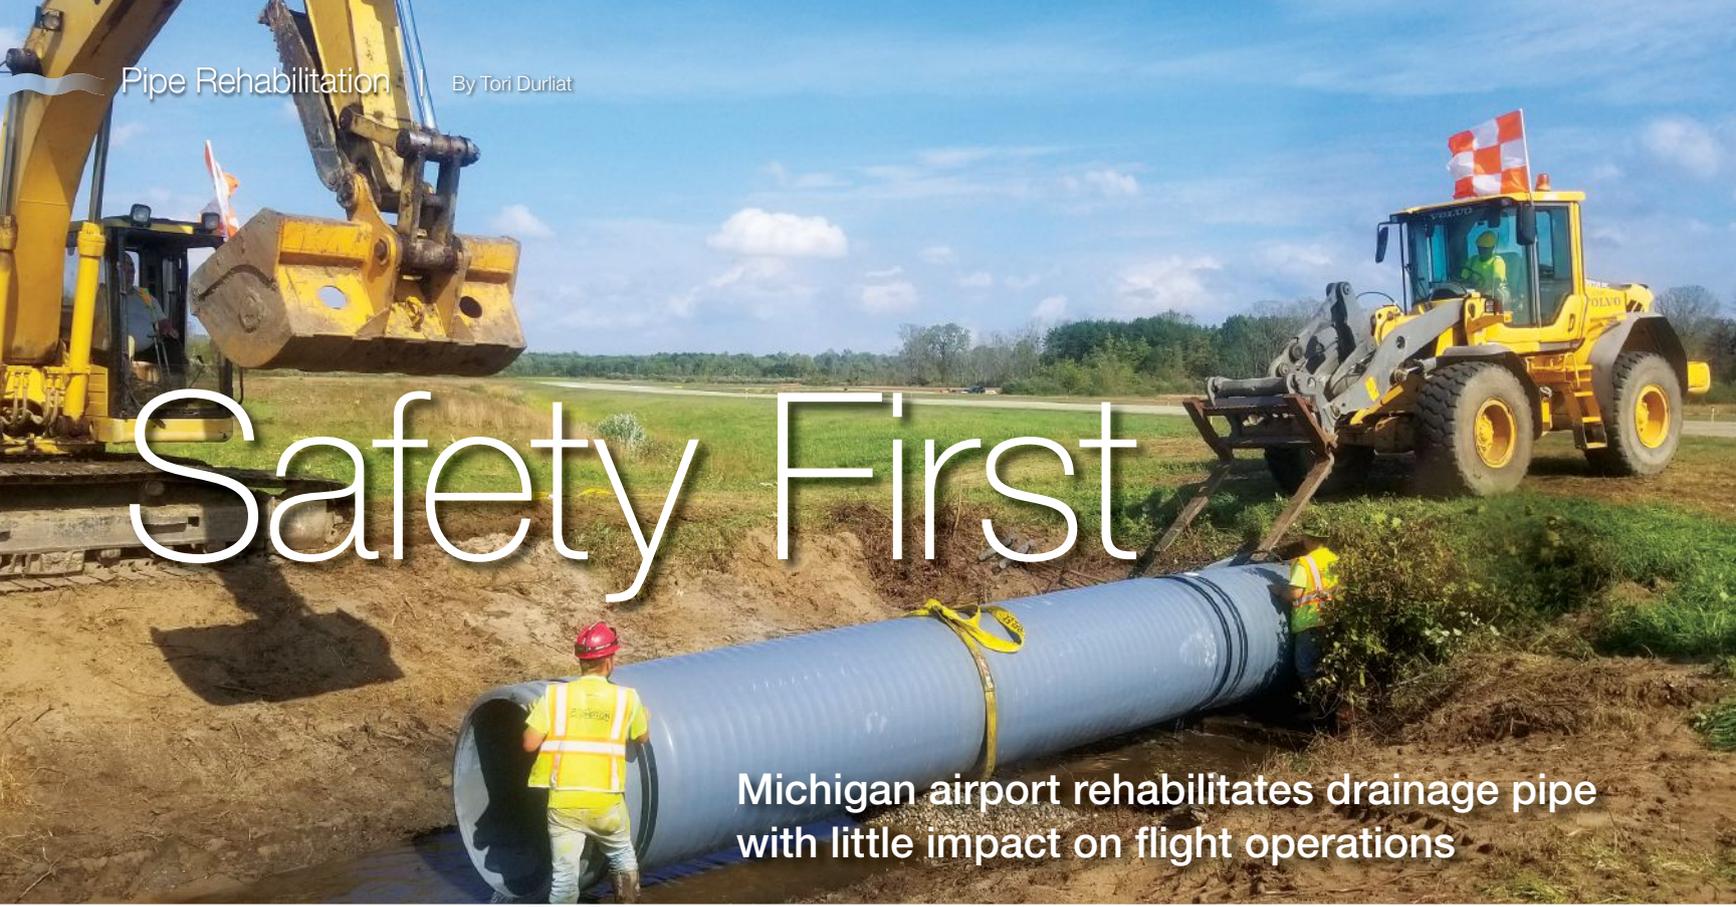
Above: A 300-ft pipeline was installed below the South Haven Regional Airport's main runway without impacting flight operations.

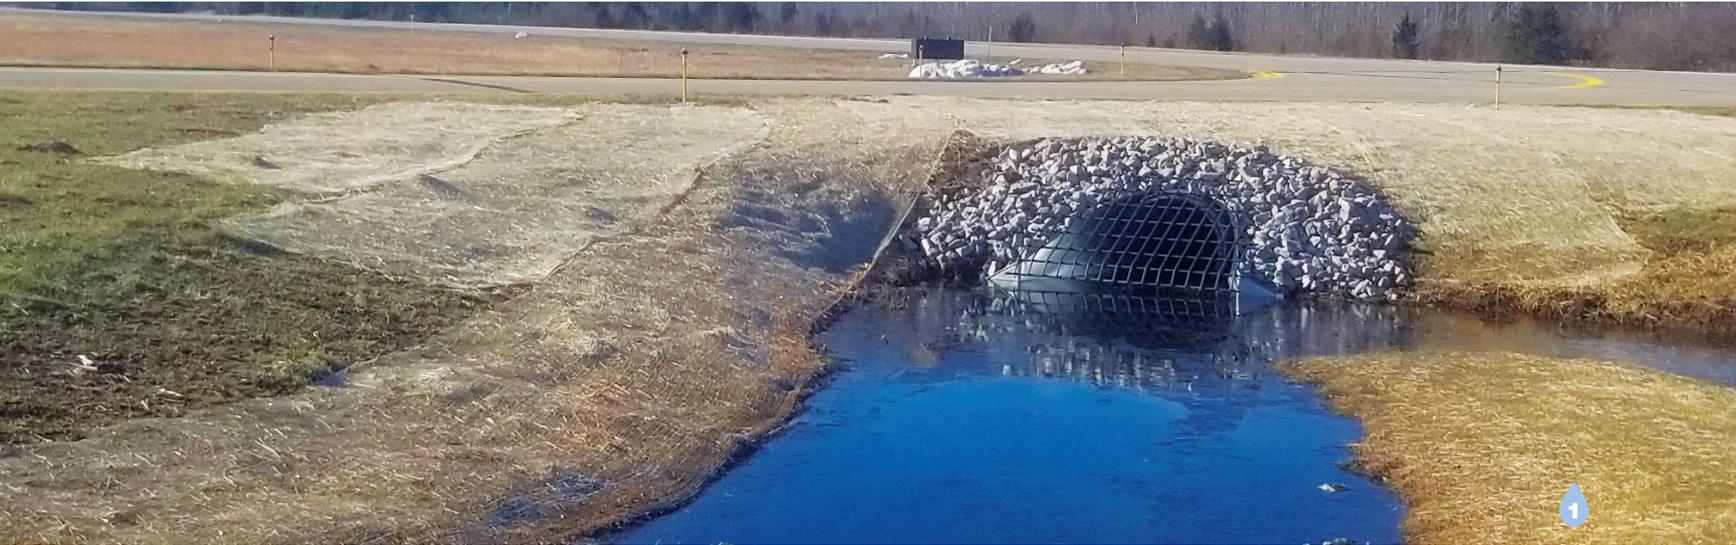
1 After the new pipe was pushed into the old pipe, the space between them was filled with controlled low-strength material flowable fill grout, and grates were attached at each end.

After the pipe was pushed into the old

CMP, the space between the old and new pipe was filled using controlled low-strength material flowable fill grout. Grates were attached at each end.

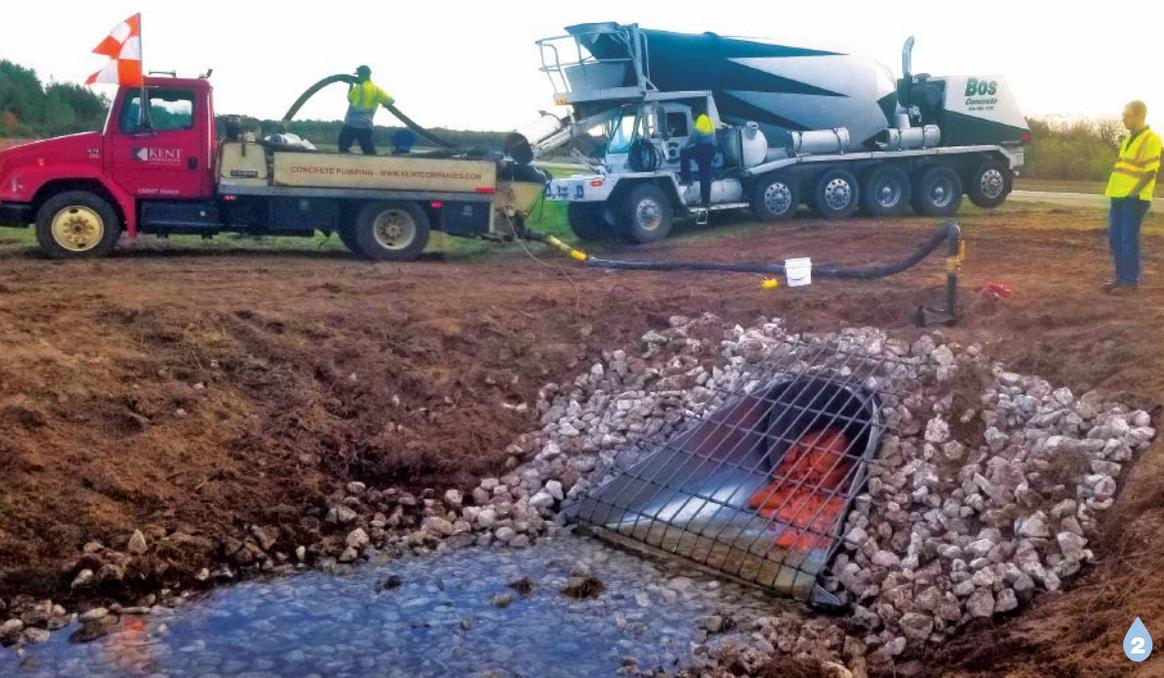
2 The pipe's smooth inner wall improves water flow.

The new pipe is made from an engineered grade of polypropylene resin, and is constructed with triple walls that give it the high degree of stiffness and beam strength needed

for sliplining projects. The two gaskets and reinforced inline bell provide the watertight joint meeting ASTM D3212 requirements and the pipe meets or exceeds ASTM F2881 and AASHTO M330. For the new pipeline, nine 13-ft-long and eight 20-ft-long lengths were used.
